DEFENDANTS' MOTION FOR SUMMARY JUDGMENT—EXHIBIT 2
RICHARD CLARKE EXPERT REPORT (JAN. 24, 2018)

Re: **Clarence Edward Whitaker. etc., v. Hyundai Motor America, Inc.**
2007 Hyundai Santa Fe
VIN: 5NMSH13E57H041555
Case # R-1128

Report of Investigation and Analysis

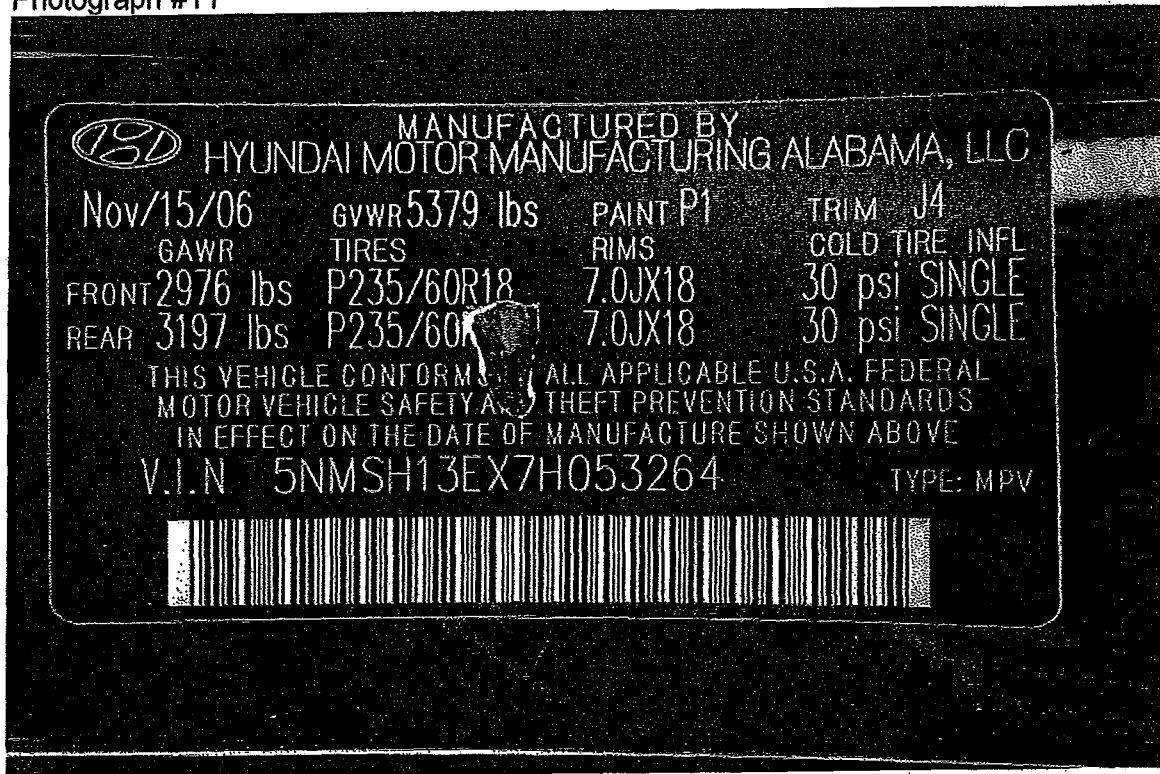
Photograph #11

1. The inspection of the exemplar 2007 Hyundai Santa Fe VIN 5NMSH113EX7H053264 on November 8, 2017 was at Clarke Automotive Consultants Inc, as shown in photographs 11. The odometer revealed 118,522 miles at the time of the inspection, photograph 12. The knee bolster was removed to gain access to the ignition interlock solenoid and connector, as shown in photographs 13 & 14. The ignition key could only be removed when the gear shift lever was in Park (P), when the ignition interlock solenoid was disconnected the exemplar functioned the same as the SV.
